DEPARTMENT OF NATURAL RESOURCES

Division of Oil, Gas and Mining

Inspection Report Minerals Regulatory Program April 21, 2010

Mine Name: White Cloud	Permit Number: S/015/0044
Operator Name: Sutherland Brothers, Inc.	Inspection Date: 03/25/2010
Inspector(s): Brett Gregory for Wayne Western <i>WFW</i>	Time: 2:00 pm
Other Participants: None	Mine Status: Inactive

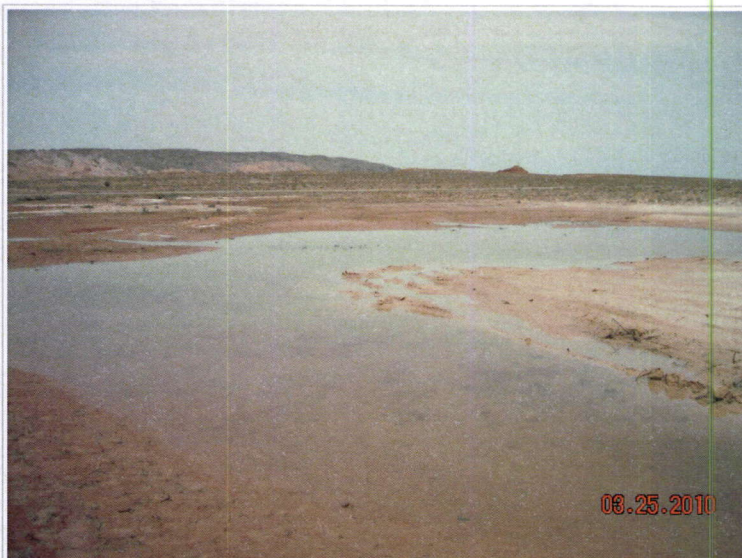
Natural water collection area.

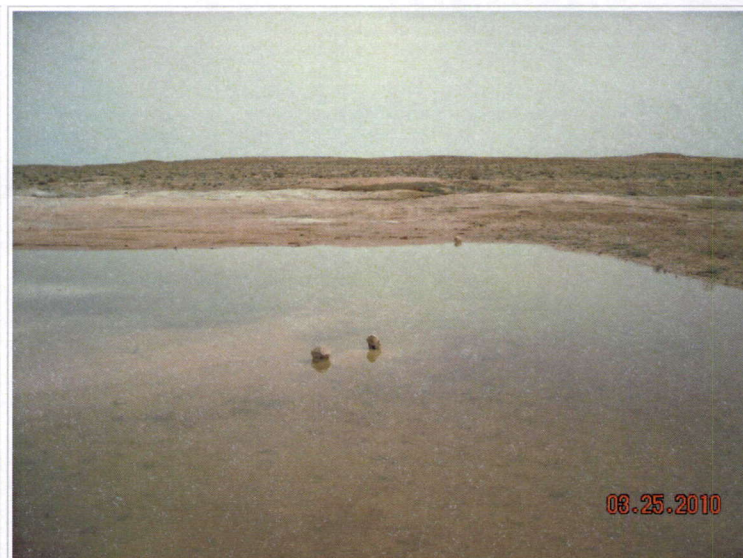
Natural water collection area.

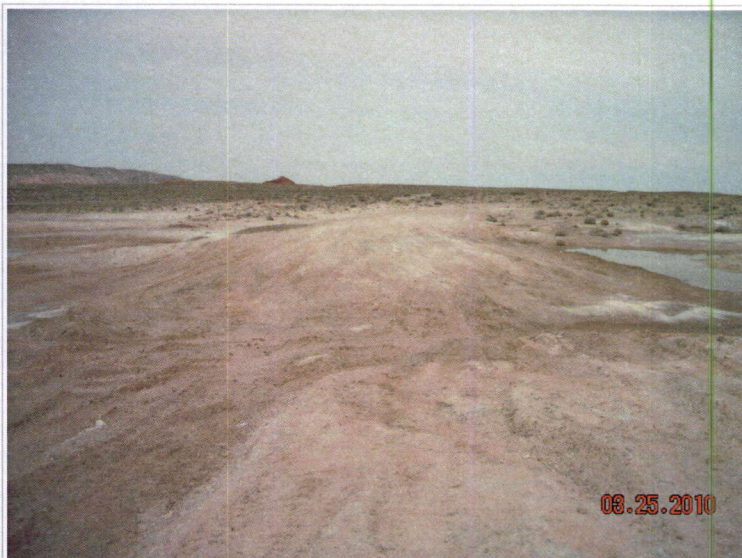
No vegetative ground cover established. (See regulation R647-3-109.13.11)

The site has been adequately regraded for post mining land use. The BLM will make an attempt to reseed the site this coming fall. The operator should participate in all revegetation efforts for at least the first three growing seasons, according to rule R647-3-109.13.11. Past due permit fees need to be paid in the amount of \$150 dollars. It is my recommendation, after delinquent fees are paid, to officially terminate the mining operation and release the site.

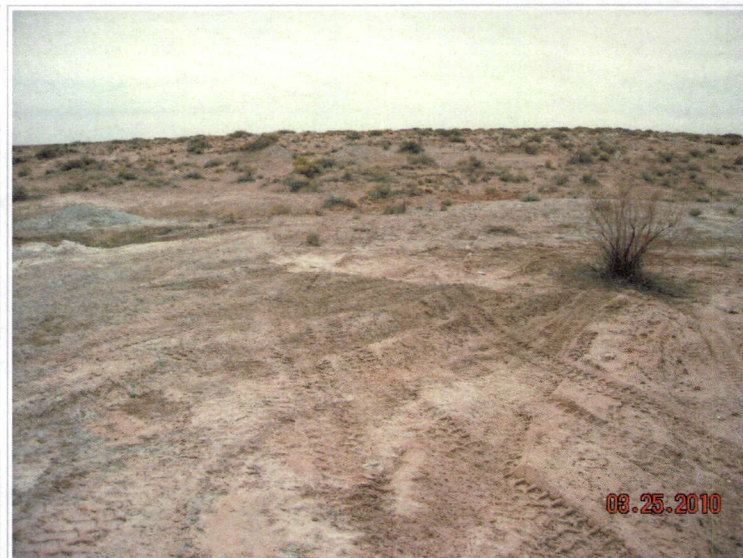
No vegetative ground cover established. (See regulation R647-3-109.13.11)

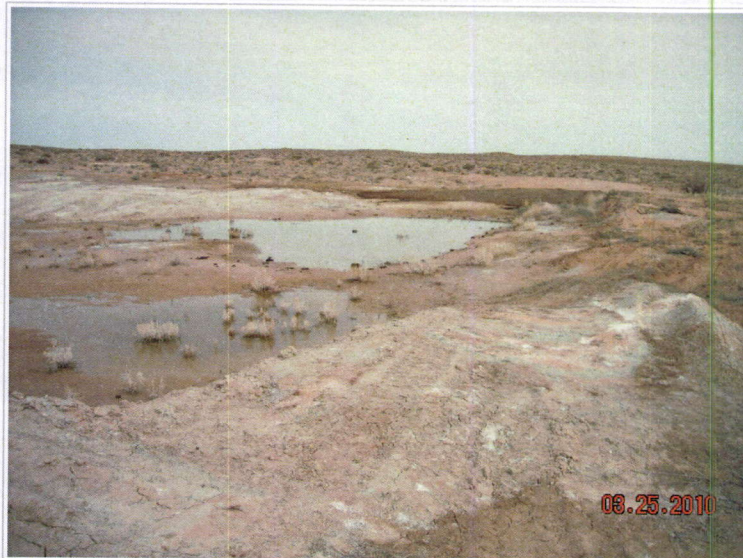
Water depressions found on regraded surfaces.

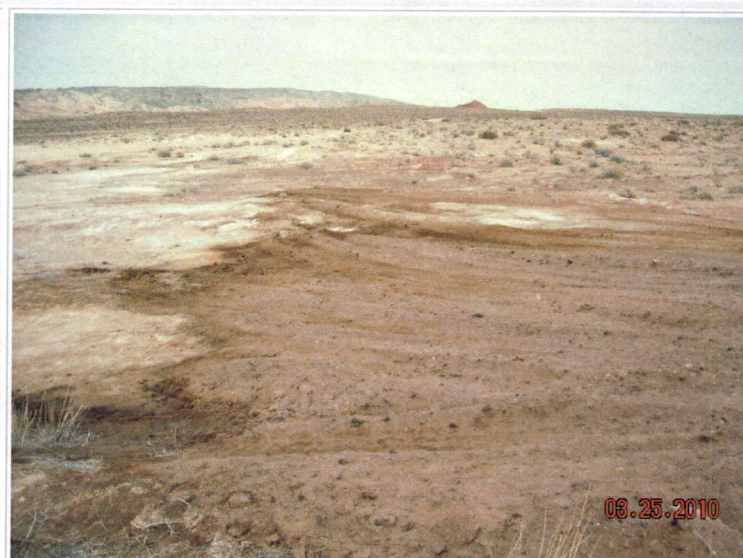
Regraded disturbance.

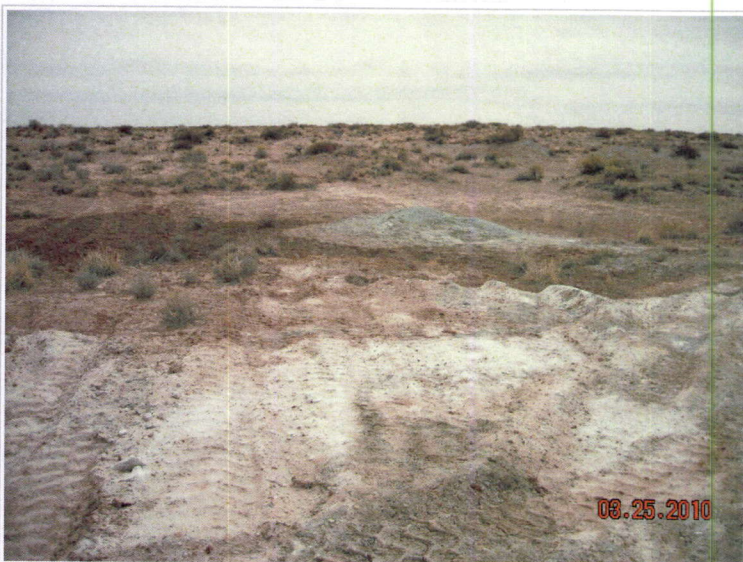
Fresh tracks showing regrading efforts.

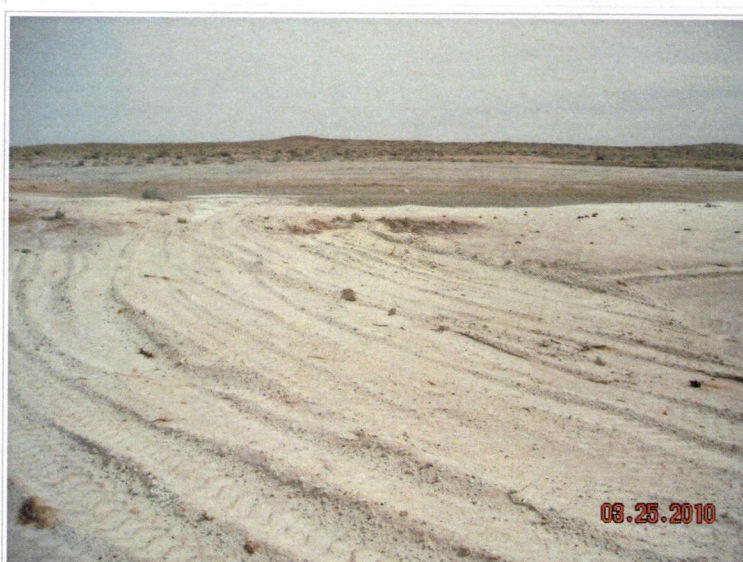
Fresh tracks showing regrading efforts.
